Re: Middle Ground Shoal Platform, Natural Gas Pipeline Release
Middle Ground Shoal Gas Leak Sampling and Monitoring Plan Summary Report
Sampling Period #3 ending 04/04/2017

Cook Inlet Water Quality and
Air/Water Interface Sampling
Photo Log: Week 3
3-29-17

Cook Inlet Alaska Methane Pipeline Leak
Water Quality Sampling Report: Week 3

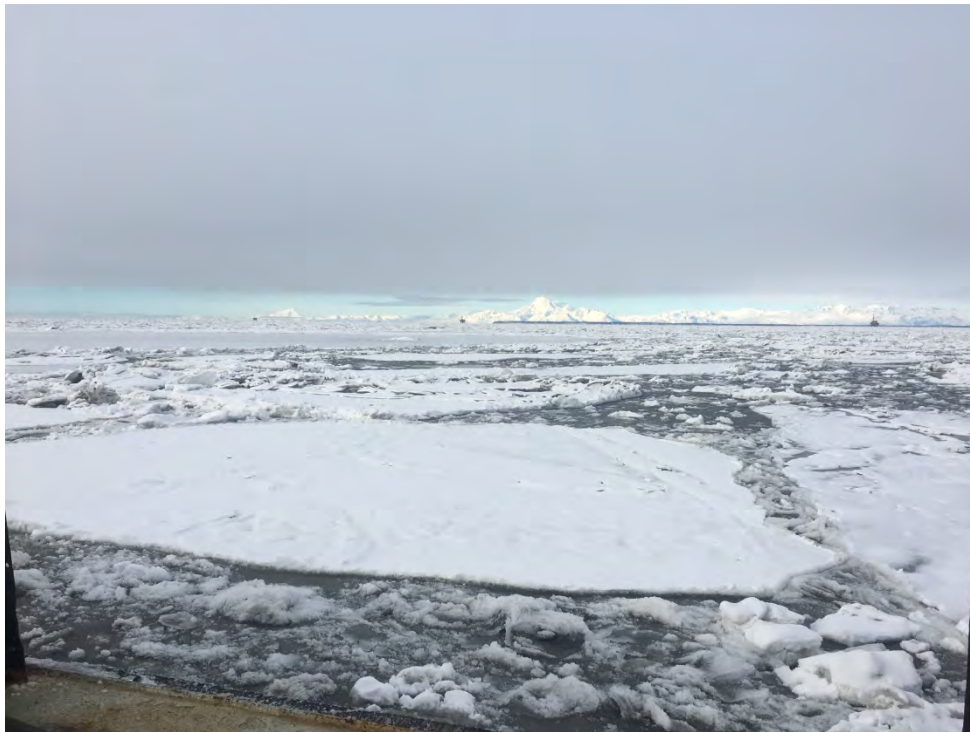
Photo 1: High ice coverage conditions during drift #1

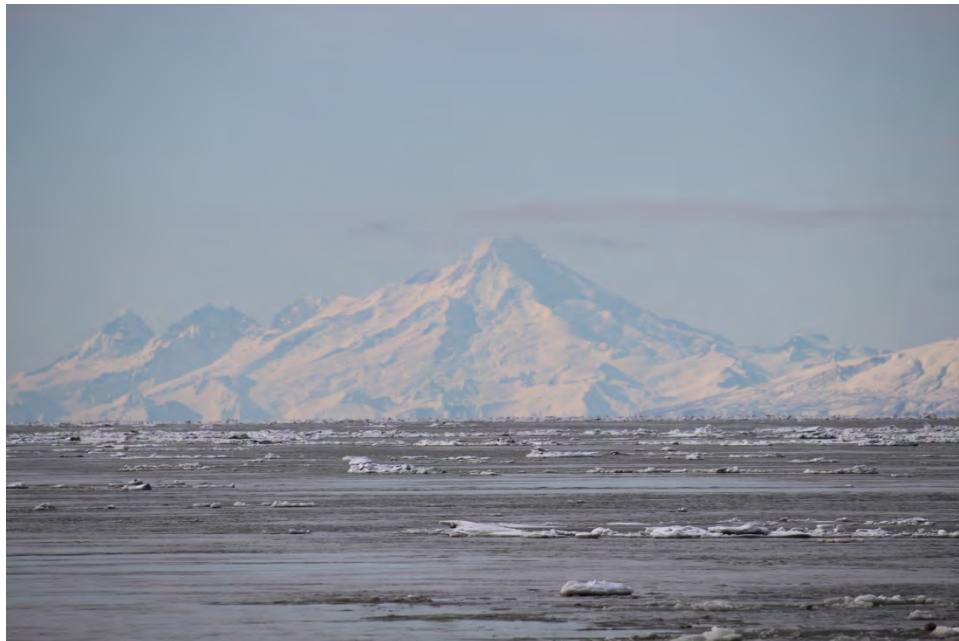
Photo 2: Drift #2 conditions with reduced ice coverage.

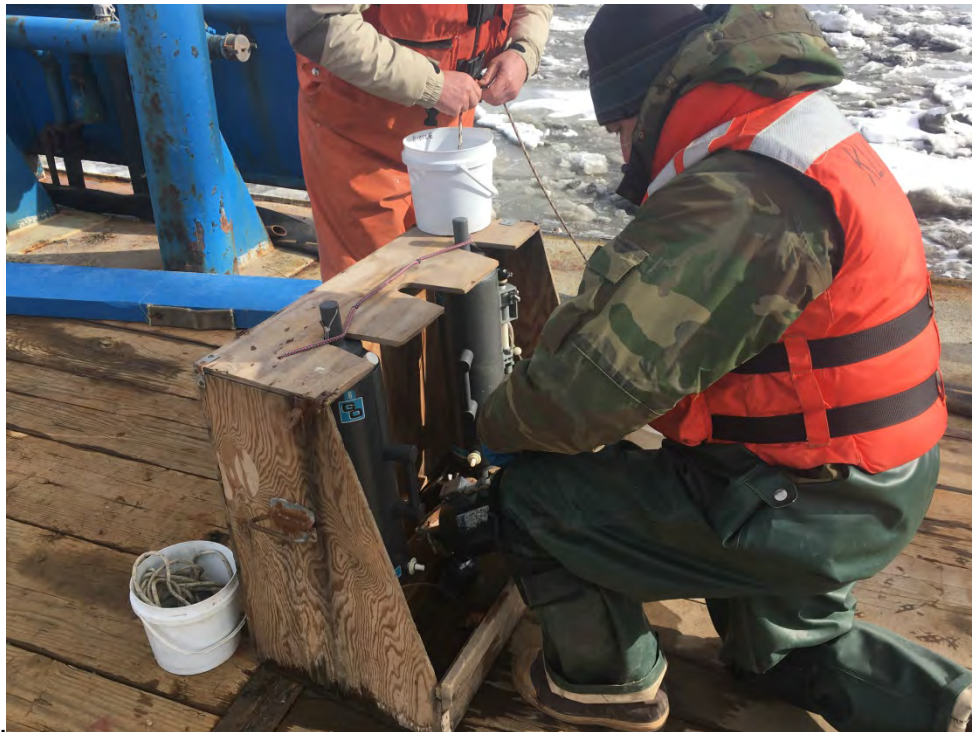
Photo 3: Preparing Niskin bottles for deployment. Note ice conditions visible in upper right.
